### **The Restoration of a Cal 40**

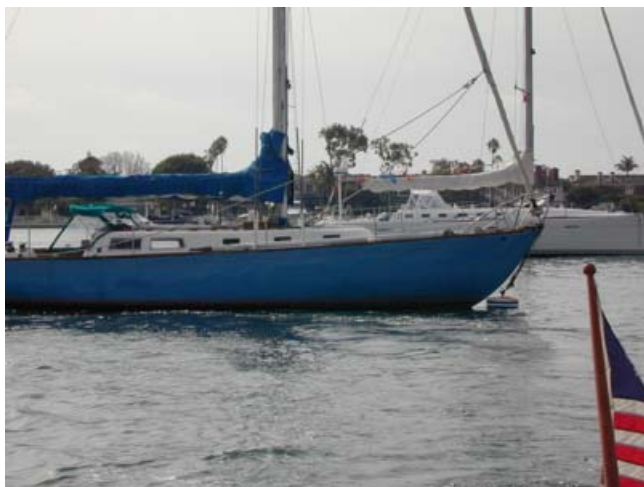
The blue hull paint was in poor condition. The engine ran but leaked oil. The mast paint was flaking off, the winches were frozen. Most of the gear was inoperable.

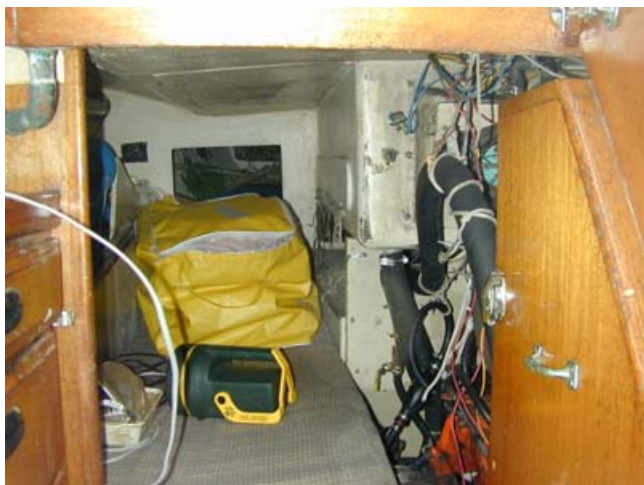
The interior was in fair condition except for old, mildewed cushions that would have to be replaced. The engine box, a heavy awkward thing at best, had been cut and modified to fit an engine that was too big for the space. It would have to go. There was a lightweight racing ladder that was tubular steel with teak treads. With a small modification, that is our ladder today. The wiring was old and the panel needed replacing. I had a new lightweight engine box built.

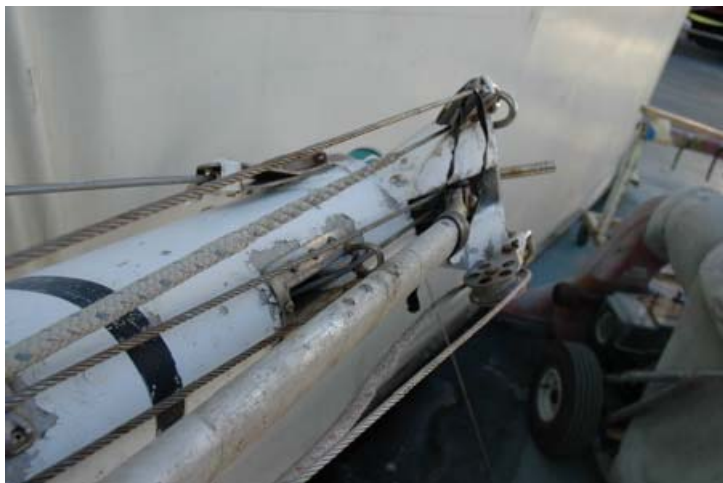
It shows old wire halyards and sheaves plus it had a reel winch that was almost impossible to get off. We saved the roller furling gear but the rest went to Minney's.

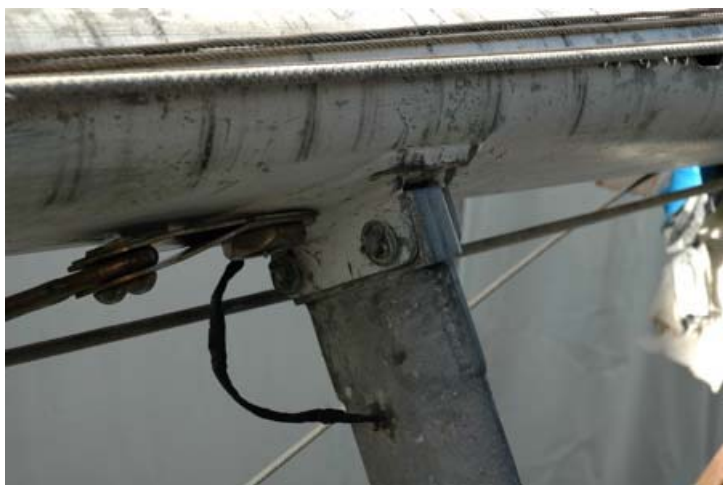
The spreader tangs were corroded and the tip fittings could not be opened to change the shrouds. They were junk.

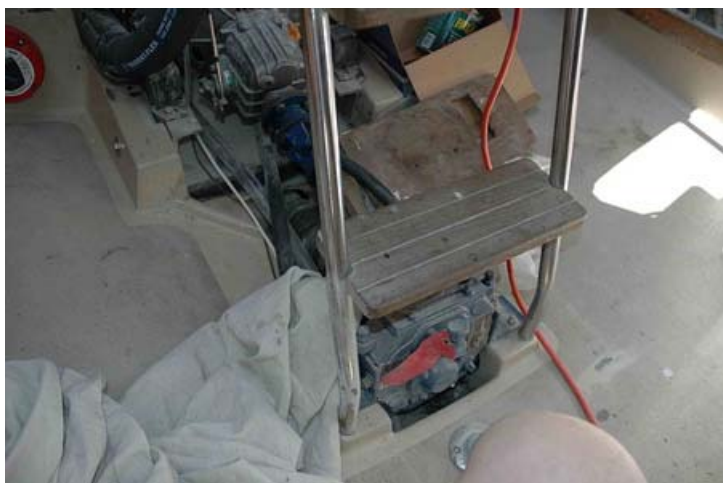
The new v-drive is seen beneath the bottom step of the ladder. The yard made a mistake in ordering the v-drive as the old engine had a one-to-one gear ration in the transmission. The Yanmar does not have a one-to-one option and the engine we installed had a 1.67 to 1 gear ratio. Unfortunately, the v-drive had been ordered with 1.67 ratio, as well. It had to be shipped back to Walter and rebuilt as 1 to 1 and returned. One concern was the tabbing of bulkheads to the hull.

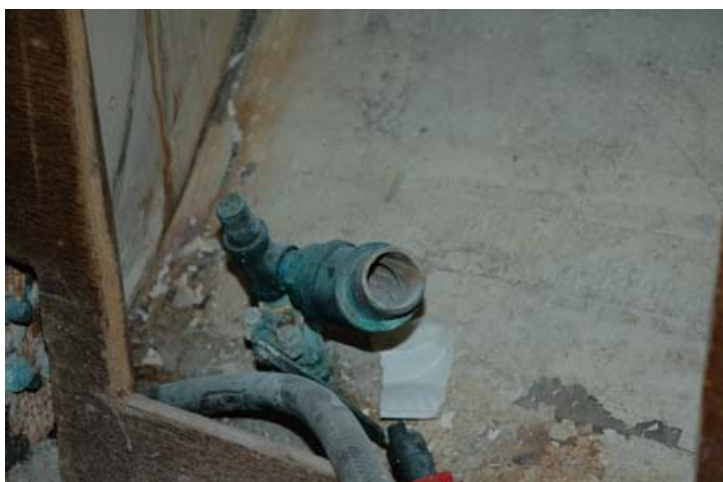
Here you can see the space beneath the head vanity cabinet. The thruhull for the sink drain and the head water intake is seen in the center. It was replaced before launching along with most of the others. The bulkhead, which carries the load from the port chainplate, attaches here to the hull. This bulkhead is also attached to the beam by several steel plates welded to the beam and bolted to the bulkhead. The plates can't be seen here.

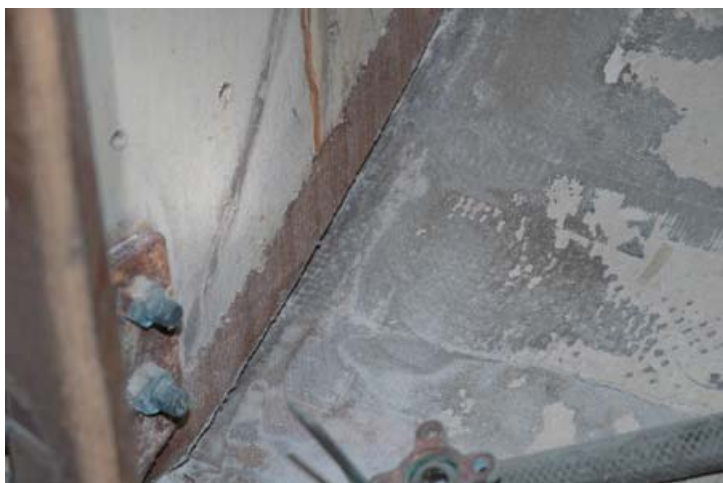
Here the debris from scraping the hull is gone and the area of the bulkhead tabbing can be seen clearly. The tabbing was loose and has been removed. One of the plates that attaches the bulkhead to the beam is shown at the left side of the photo. This tabbing was replaced before the thruhull was replaced and other work done that would have obstructed access to the area.

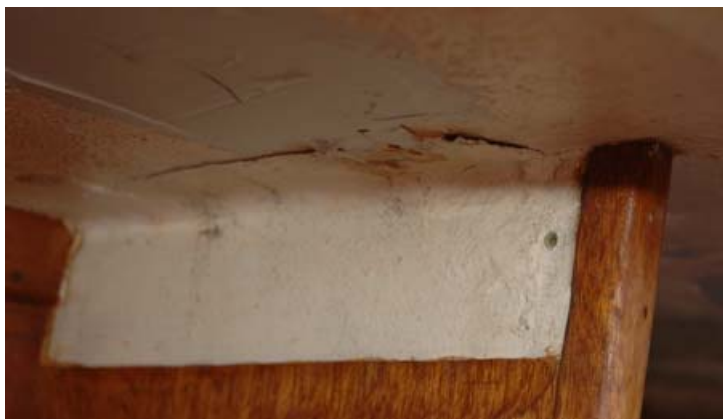
Here, tabbing from an aft bulkhead to the deck is seen and is disrupted. This is the area where the genoa track was (We removed it and filled the holes) and the load on the deck has pulled it up from this half bulkhead, which is just forward of the ice chest. This area was also ground down and retabbed.

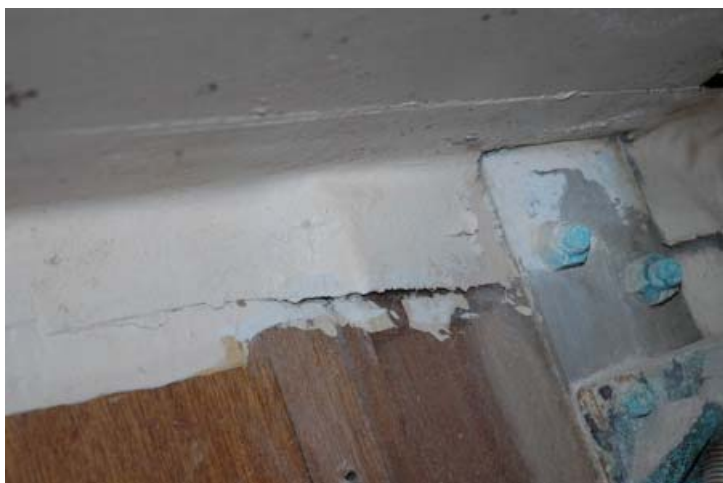
Here, another area on the starboard side, is seen with disruption of the tabbing from bulkhead to deck. This is adjacent to the starboard chain plates. It was ground down and retabbed.

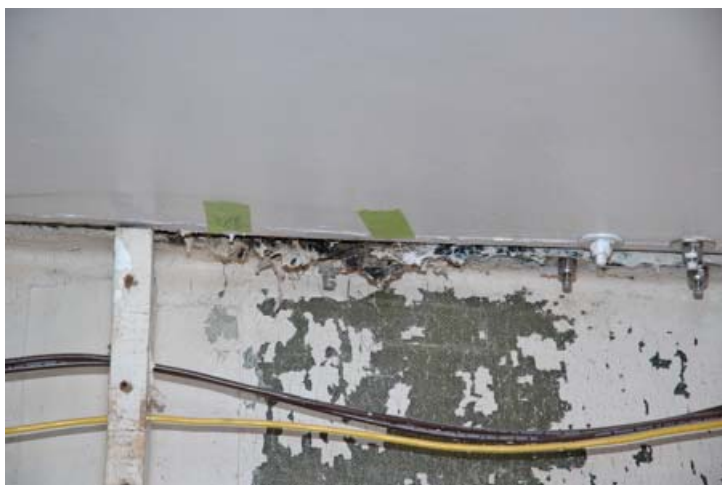
The starboard bow also proved to have the worst leak site in the hull-deck seam. A closeup is seen here and running a hose on deck would produce a flood below. This was not fully appreciated until the hull had been painted. I was also not eager to learn what the yard would charge to replace the toe rails. Both toe rails were cracked at a point opposite the forward end of the deckhouse. My theory is that this was a result of the Bermuda Races with flexing of the deck and hull where the reenforcement of the deck stiffness, which is increased by the cabin sides, ends. The leak site is marked with green tape. I tried squirting caulk in there but only the toe rail job would fix it. That came a year later.

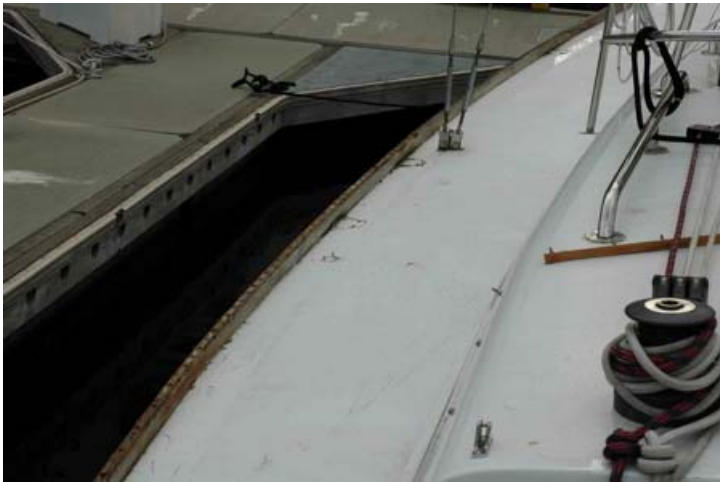
The toe rail was cracked at the forward end of the cabin on each side and there was a serious leak in the hull-deck seam that required

repair. Wendy Siegel had done a repair before the 2005 Transpac but her toe rail was in better shape than ours. They had raised the starboard toe rail to access the seam and Duncan had repaired the seam by sealing it with fiberglass and then the toe rail was replaced and resealed.

The old rails were in poor condition so they were removed and discarded. Here the tracks had been removed and bolts taken out. The rails were lifted and the holes all sealed along with the seam.
