### **The Restoration of a Cal 40**

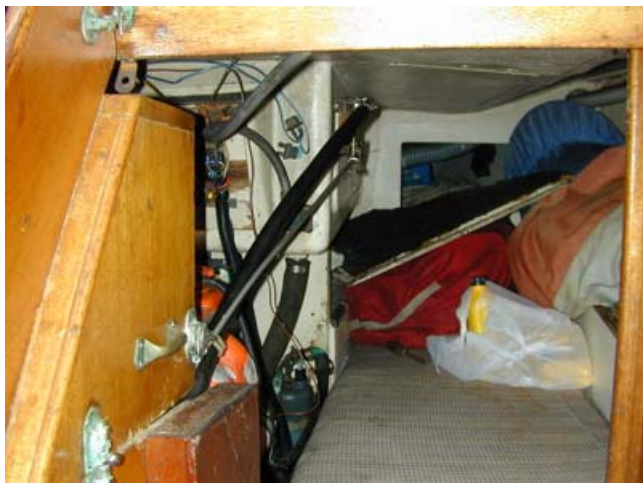
The engine controls were old and were on the wrong side for the new engine we ordered. That would have to be switched. Also, I like the Morse sailboat controls, which allow the two handles to be removed when sailing. Unfortunately, Morse doesn't make them anymore but I found a set in Minney's Chandlery.

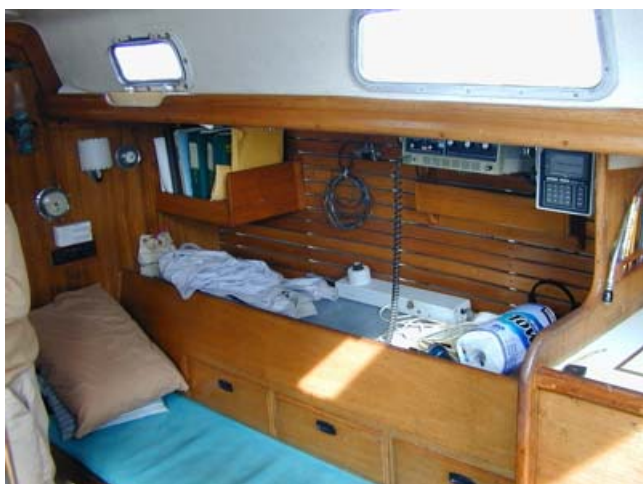
The cabin was filled with obsolete electronics, like the old VHF radio above the pilot berth.

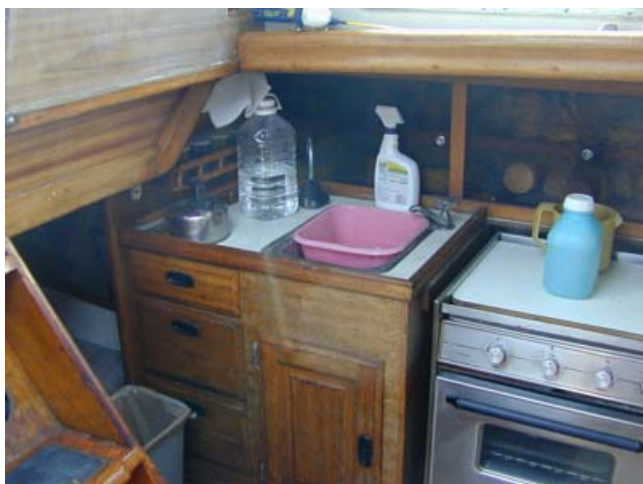
The galley was OK and the pressure water worked but the fittings were old and the water tank looked like it needed replacing. We took the stove home and cleaned it up. It was CNG and, for reasons that are a mystery to me, CNG has fallen out of favor as a stove fuel in boats now. It is far safer than Propane, although it does not have as high a specific heat. Propane requires a sealed box for the tank with electric controls as it is heavier than air and will collect in the bilge if a leak develops. Getting a new regulator, as the old one had a broken gauge, turned out to be difficult. Ironically, the only source for CNG equipment anymore is the company, [Corp Brothers](#), that was owned by Avery Seaman, the former owner (before it was brought west) of the boat. His family still owns the company and his granddaughter promised to send some photos of the boat when it was in their family. They haven't arrived yet.

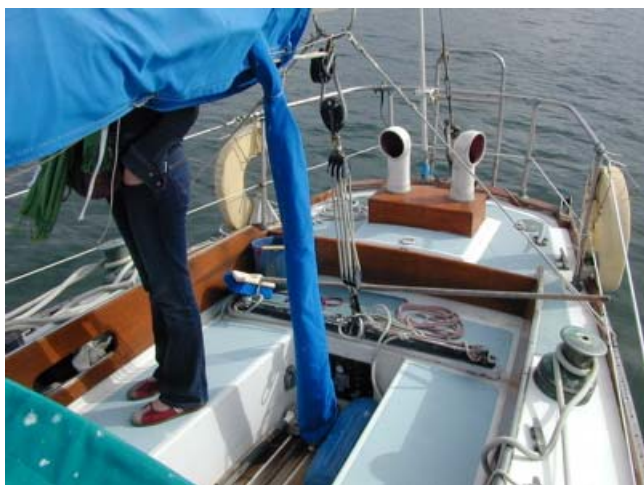
My daughter is standing in the aft cockpit. Behind her are large vents for the lazarette, which are mounted on a Dorade box. They looked like line snaggers. The main sheet rigging was in poor condition and I reregged that completely. The traveller was replaced with a new Harkin model.

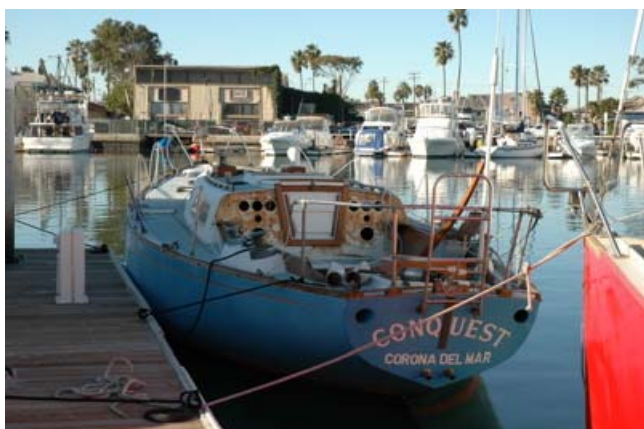
The cockpit bulkhead was full of old instruments that no longer worked. They had to go but the holes needed filling. We pulled the mast, intending to refinish it, and hauled the boat. Mike Jr and I worked for weeks stripping off all the gear. The old engine, a Pathfinder diesel, went to the Boy Scouts. The V-drive was not salvageable and was junked. The winches were chromed bronze and were frozen. I took them home and worked on them, eventually trading them to Minney's chandlery for credit on Barient 28 stainless winches. The mast was corroded at the base and under a couple of winch pads so I junked it (It's at Minney's) and bought a new mast. We kept the old boom as it was not original. My biggest mistake was not replacing the toe rails but we didn't know how badly the hull-deck seam leaked until a year later. Mike and I spent months stripping gear and filling holes in the deck. I took the lazarette hatch home, removed the Dorade box, and filled the holes with glass. The forward hatch remained but I eventually replaced it with a Lewmar hatch about a year later. We did not find any rot in the core although some of the commissioning was a bit sketchy. It had survived seven Bermuda races when it was owned by Avery Seaman. George Griffith had sailed four of those races aboard and he later told me that he always arrived a few days early to check out the boat. He brought fiberglass tape and resin with him and usually wound up retabbing some of the bulkheads. The Bermuda race, which crosses the Gulf Stream and is usually upwind, is hard on hulls. About 30 years ago, a production boat drove the mast step right through the hull in the severe seas of the Gulf Stream. Many fiberglass hulls are laid up in two halves and later bonded together. That mast compression load split the hulls. The Cal 40 has a steel beam under the step so the load is not on the hull there. I'll describe the truss arrangement of the rig later. It was a big innovation that allowed Lapworth to design a light hull in the days when fiberglass was a new material. The mast was another matter. It was going to be more expensive to refinish it than to replace it since I was going to have all new rigging anyway.

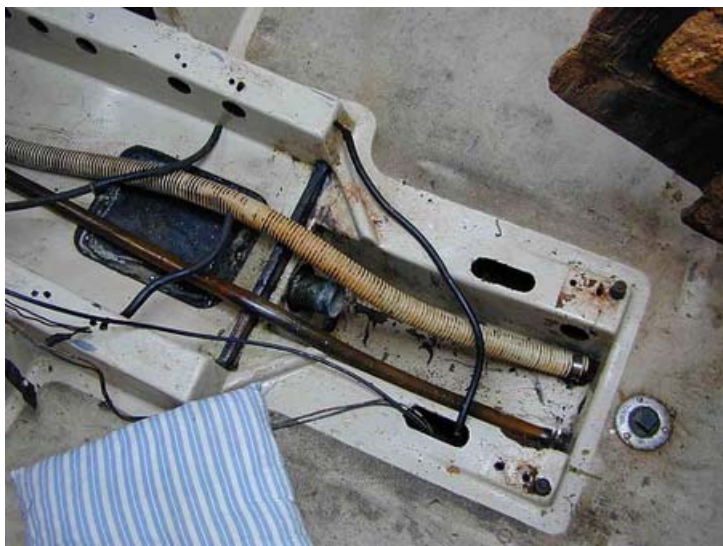
The engine bed shows both engine and v-drive gone. This exposes the inner end of the shaft log, the bronze tube that holds the shaft. The inner end has a packing gland or, as we chose, a “dripless gland” to seal off the sea. The metal plug to the right is a fill cap for a racing tank that had been installed in the bilge. It held about ten gallons but had been disconnected and a tank fill cap below decks is illegal anyway. We had to cut the tank up with a Sawzall to get it out. The engine mounts were too far apart for the new Yanmar 3YM diesel so the yard fabricated new ones from angle extrusions. The two hoses, one a white hose and the other oil stained clear plastic, are bilge pump hoses. We stripped out all the hoses and all the wiring, completely rewiring the boat. The water tank was original and the fittings were bad so I had a new one made. As it turned out, [the metal shop](#) we chose had built all the tanks for Cal boats back in the 60s when they were across the street in Costa Mesa.

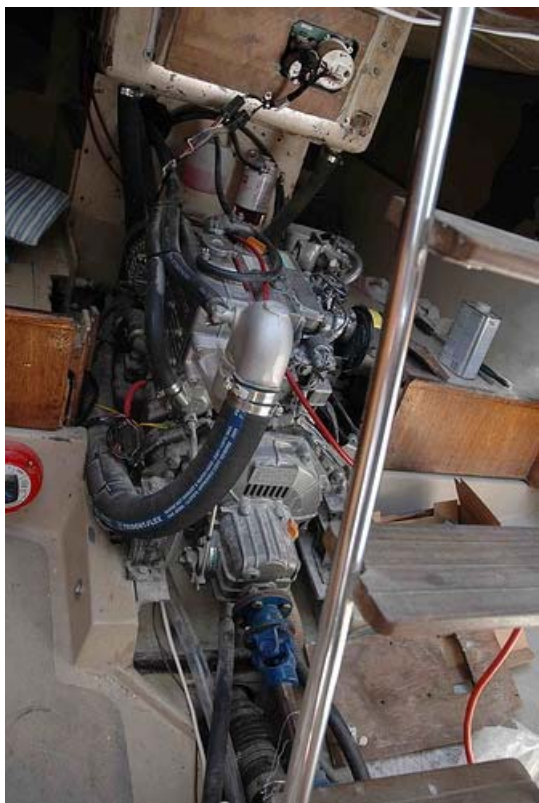
The new engine is installed and the new engine mounts can be seen below and to the left. Our steel ladder is also in the picture. The first photos of the engine bed showed an ancient corroded automatic battery charger. It is now gone and replaced by the coolant reservoir and a fuel filter. The back of the new engine control panel is above. The engine instruments are to port allowing room for additions in the future.

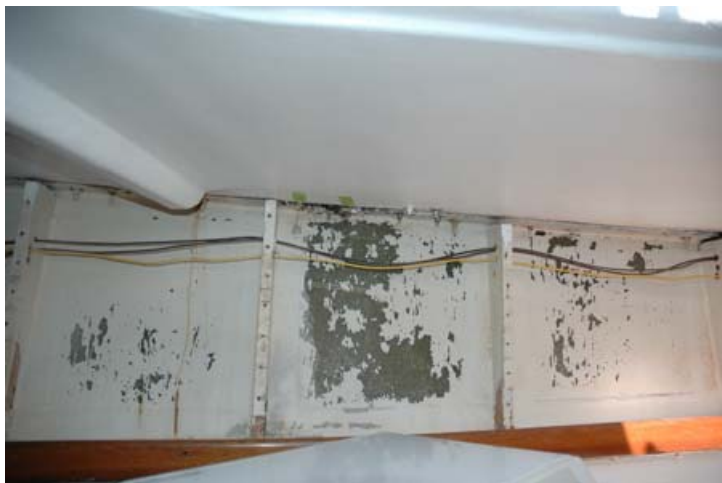
With the battens removed, the hull was exposed and could be scraped and sanded. After glass repairs were completed, the hull was painted with two coats of Kilz primer and two coats of Sears Kitchen and Bathroom paint. This paint is supposed to resist mildew.
